Wareham Historical Society Historic Building Survey

October 21, 2013

Great Neck Union Chapel
Old District School No. 6
Old Methodist Meeting House
Fearing Tavern Museum
Captain Kendrick House

DURLAND ■ VAN VOORHIS

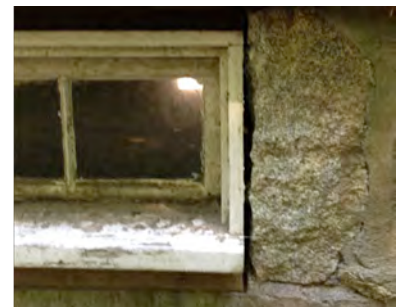
UC-5 Basement window replacement

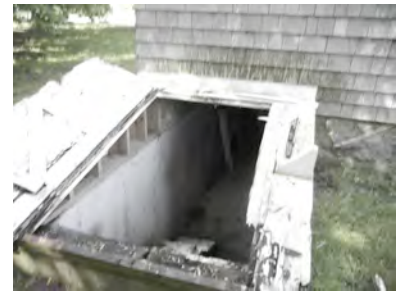
when the building was moved. The doors and interior steps are in very poor and even dangerous condition (UC-6). They should be repaired or replaced very soon. At the minimum, the opening should be protected with heavy plywood immediately to prevent injury. The deterioration of the stairs and bulkhead door appear to be caused by high levels of moisture. This could be a result of roof runoff falling on the doors or storm runoff finding its way into the basement, where it becomes trapped and supports mold growth and rot. Installing a dehumidifier in the basement would help remove this trapped moisture. Positively pitching the grade away from the building or installing a perimeter drainage system are two other ways of managing storm water runoff (UC-7).

UC-6 Bulk head door

The bulkhead door is severely deteriorated and fell apart when I opened it. I suggest the opening be secured immediately to prevent access to the basement and suggest rebuilding the bulkhead door to fit the existing building opening (UC-6).

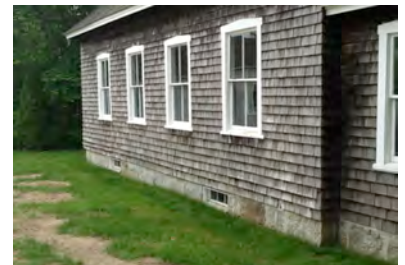
UC-7 Pitch grade away from foundation

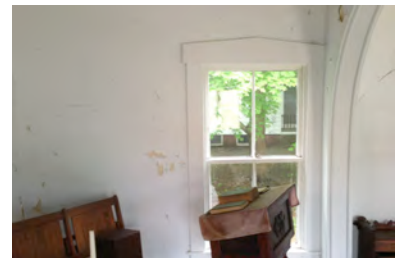
There are signs of water infiltration around the small brick chimney at the southwest corner of the sanctuary (UC-12). The flashing should be carefully inspected and replaced to eliminate any source of water. The interior plaster has many cracks, typical for a building of this age (UC-13). These can be easily repaired, but unless the movement is corrected they are likely to reappear over time.

UC-13 Typical interior plaster cracks

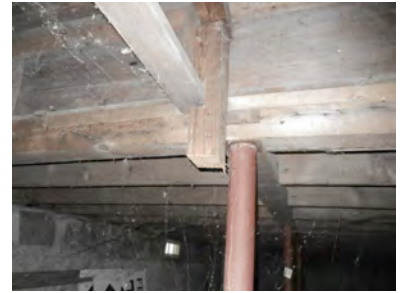
The 1st floor framing under the seating area is 2x6 joists, spaced 24" on center, spanning approximately 7'-6" continuous over a 6x6 beam support at mid-span of the chapel (UC-16). The joists are notched 4" at the foundation wall (UC-20) and at the center wood beam support. Horizontal splitting at the ends of several joists was noted (UC-17). The floor framing under the rear stage area and the front 6 ft. of the main hall are 2x8's spaced at 24" on center, spanning the full width (15 ft) of the building (UC-18).

UC-16 Center beam supported by columns

Connect each existing 2x6 joist to the foundation wall sill plates and to the intermediate 6x6 wood beam with new metal joist hangers sized for the appropriate floor loading.

Add a new wood beam at mid-span (in line with the existing 6x6 wood beam) of the 2x8 floor joist under the rear and the front 6 ft. Connect each existing 2x8 joist to the foundation wall sill plates and to the new intermediate wood beam with new metal joist hangers sized for the appropriate floor loading.

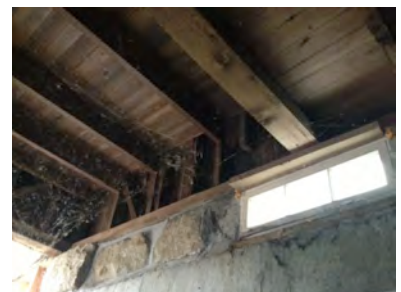
UC-20 Existing foundation & floor framing

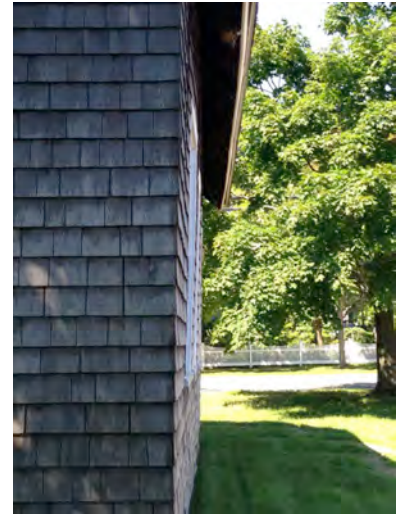
The exterior side walls of the Chapel are noticeably out of square and not plumb (UC-21). There is evidence of cracking on the interior walls and ceiling finishes that is indicative of movement of the exterior walls as noted from a small ceiling hatch, the ceiling/attic joists are supported by the exterior wall and hung from the roof rafters (UC-22). It appears that the attic/ceiling joists are nailed into the side of the wall studs, eg. below the wall top plate and not directly connected to the roof rafters (UC-23). Several of the attic/ceiling joists are not continuous (eg. one piece from side wall to side wall).

The attic was not easily accessible, but from a view through the ceiling hatch it appears that the roof structure is not properly tied at the eave level to resist the horizontal thrust of the sloped roof rafters (UC-24). The lack of

UC-21 North wall of Chapel

adequate ties has resulted in the horizontal movement of the exterior walls and may have resulted in cracking of the wall finishes.

It will be difficult and costly to straighten and plumb the exterior walls, however, I suggest installing new ties at the eave level to reduce the possibility of future lateral movement, damage, etc. The new ties could be steel rods or wood joists provided the ties are continuous (one piece) from eave to eave and a properly connected to the ends of the rafters.

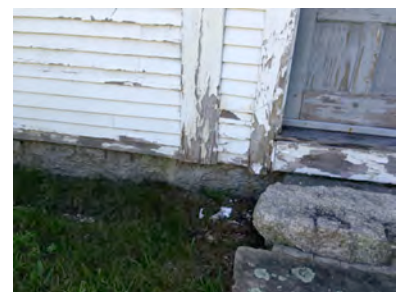
DS-4 Missing masonry joint at storage addition

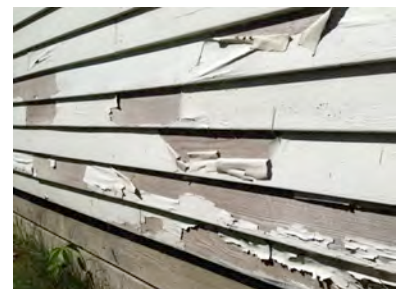
DS-5 Failing paint at east side

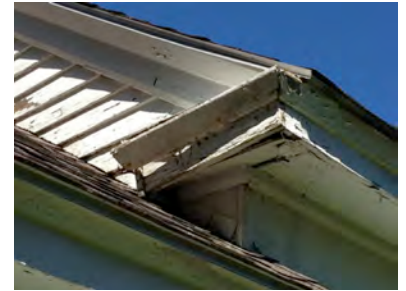
DS-6 Damaged & missing trim at eave

of them should be carefully repaired and the trim scraped, sanded, primed and repainted (DS-6).

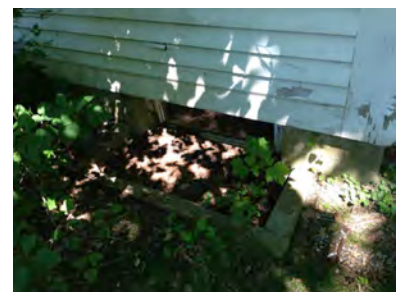
MH-5 Leaking basement window

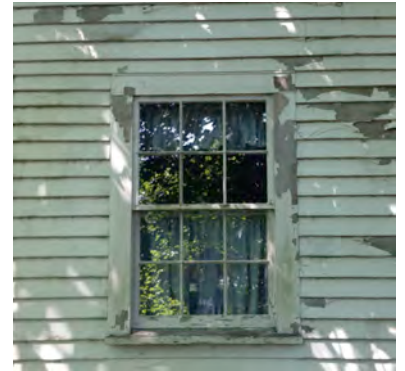
MH-6 Peeling paint

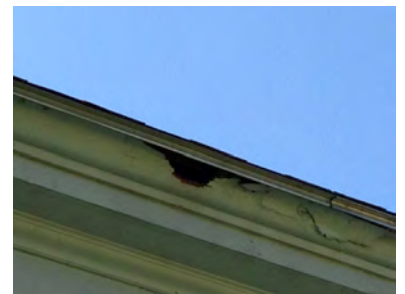
MH-7 Rodent damage

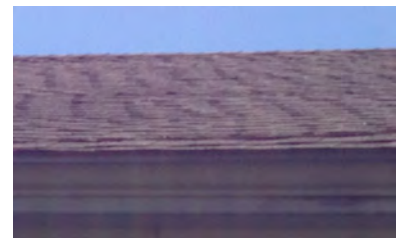
The roof is covered with asphalt shingles that appear to be in generally good condition (MH-8). There is, however, an area on the north side of the main roof where the sheathing appears distressed, however, the exact cause is not known (MH-9). The framing appears intact but displaced in this area so some repair to the top plate/girt may be required. The roof shingles and possible eave and soffit trim in this area should be carefully removed and the sheathing and framing repaired as required.

MH-8 Damaged roof area

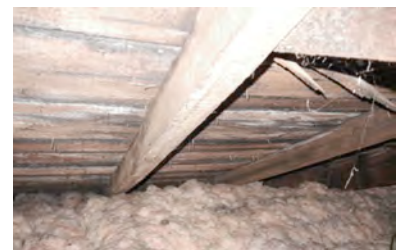
MH-9 Broken roof sheathing

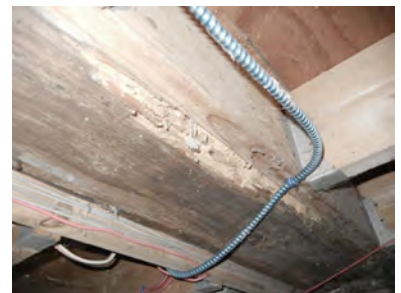
MH-14 Existing first floor framing repairs

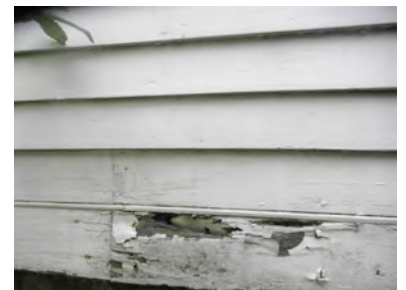
MH-19 Insect damage

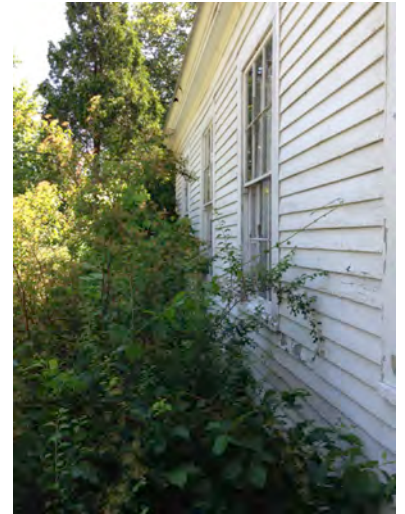
I noted the wood clapboards close to the ground have signs of rot and decay due to the ground cover too close to the clapboard sheathing and the overgrown shrubs and plantings around the perimeter promoting a wet environment (MH-19). The current conditions will at a minimum result in decay and rot of the clapboards and in the worst case create an attractive environment for insect infestation that could ultimately damage the building

MH-20 Overgrown plantings

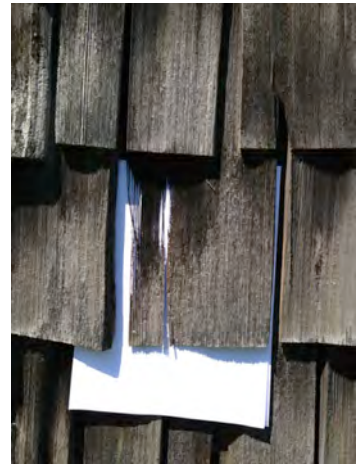
FT-6 Worn out wood shake siding

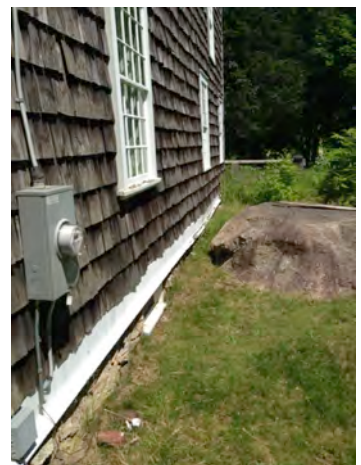
There is a noticeable bulge in the center of the east wall of the main house (right behind the large rock) (FT-7). Water washing down the rock may have caused settling in the foundation or elevated the moisture content of the sill and framing. This area has been recently repaired but should be carefully monitored. The exterior trim is in generally good condition, but should be repainted.

FT-7 Bulging east wall

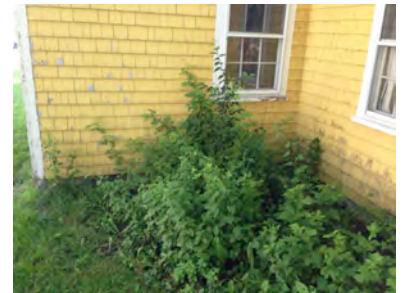
KH-2 Overgrown foundation plantings

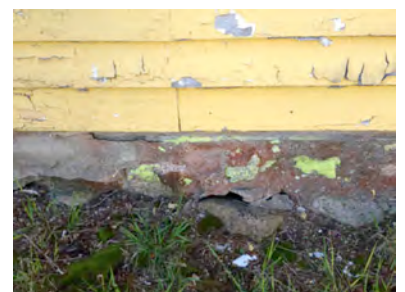
The foundation of the rear ell is fieldstone and requires some repointing and gap filling (KH-5). This should be checked regularly to prevent rodents from getting inside the house. There is a plywood bulkhead door on the southwest side of the main house. While the location may be quite old the material choice, plywood, does not integrate well with the rest of the

KH-5 Fieldstone foundation needs selective repointing

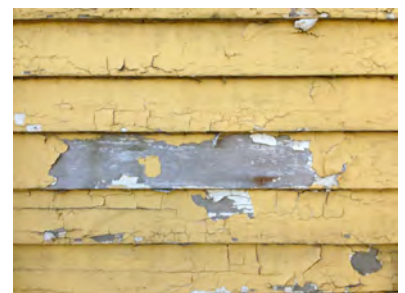
KH-9 Failed exterior paint – typical

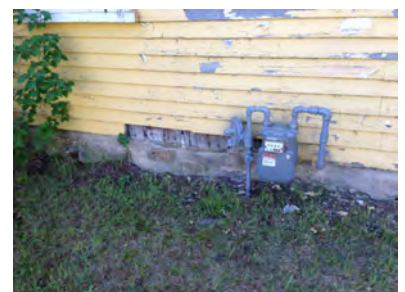
KH-10 Missing clapboard

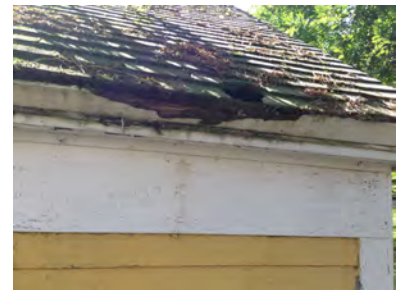
KH-12 Rodent damage at rotten trim

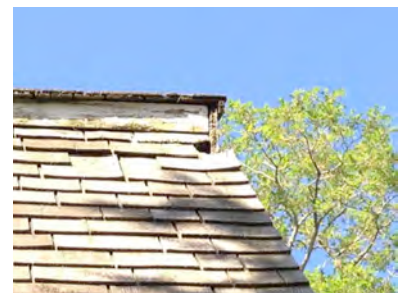
KH-13 – Missing & worn out roof shingles

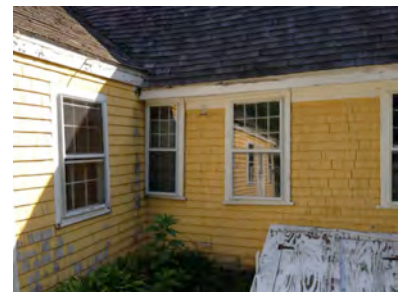
KH-15 Missing downspouts

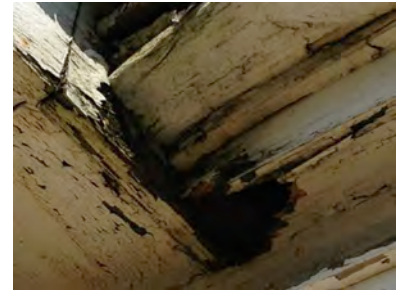
KH-16 Rodent & water damage

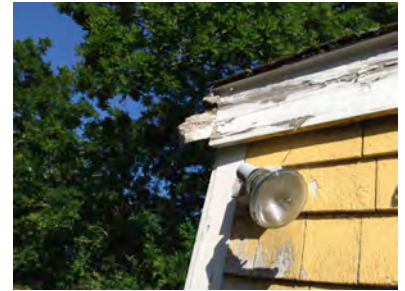
KH-20 Rodent damage at trim

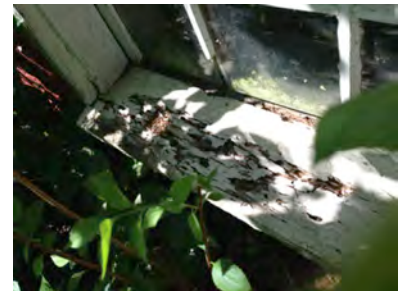
KH-21 Insect damage at basement window sill

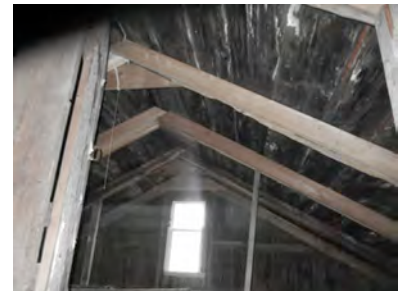
I noted several original roof rafters have been reinforced with new rafters sistered along side the existing decayed members (KH-22). The existing

KH-22 Existing roof framing
