Wareham Historical Society Historic Building Survey

October 21, 2013

Great Neck Union Chapel
Old District School No. 6
Old Methodist Meeting House
Fearing Tavern Museum
Captain Kendrick House

Re: Structural Assessment
Five (5) Wareham Historical Buildings
Wareham, MA

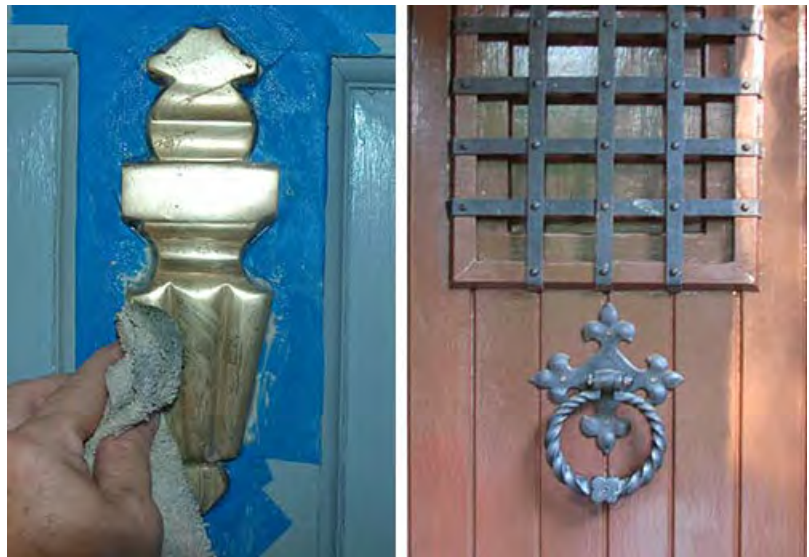
Figure 1. Maintenance involves selecting the proper treatment and protecting adjacent surfaces. Using painter's tape to mask around a brass doorknocker protects the painted door surface from damage when polishing with chemical compounds. On the other hand, hardware with a patinated finish was not intended to be polished and should simply be cleaned with a damp cloth.

Original building features and examples of special craftsmanship should be afforded extra care. The patina or aging of historic materials is often part of the charm and character of historic buildings. In such cases, maintenance should avoid attempts to make finishes look new by over-cleaning or cladding existing materials. As with any product that has the potential to harm historic materials, the selection of a cleaning procedure should always involve testing in a discreet location on the building to ensure that it will not abrade, fade, streak, or otherwise damage the substrate (Figure 1).

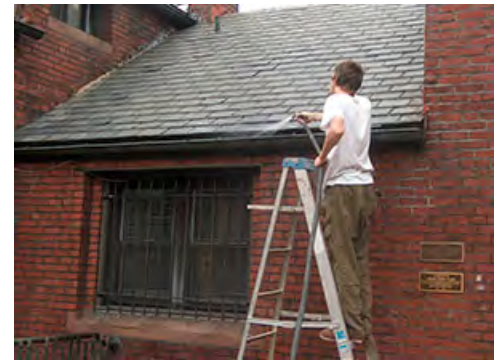
Figure 3. Keeping gutters clean of debris can be one of the most important cyclical maintenance activities. On this small one-story addition, a garden hose is being used to flush out the trough to ensure that the gutter and downspouts are unobstructed. Gutters on most small and medium size buildings can be reached with an extension ladder and a garden hose. Photo: Bryan Blundell.

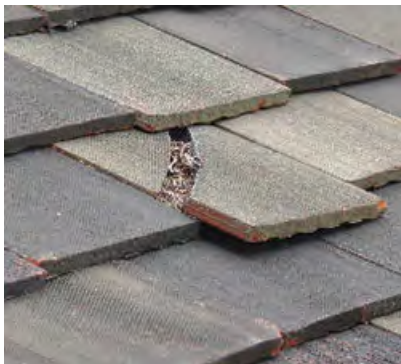
Figure 4. Damage to roofs often requires immediate attention. As a temporary measure, this damaged roof tile could be replaced with a brown aluminum sheet wedged between the existing tiles. Photo: Chad Randl.

- As a temporary measure, slip pieces of non-corrosive metal flashing under or between damaged and missing roofing units until new slate, shingles, or tile can be attached. Repair broken, missing or damaged roofing units with ones that match. Follow roofing supplier and industry guidance on inserting and attaching replacement units (Figure 4). Avoid using temporary asphalt patches as it makes a proper repair difficult later on.

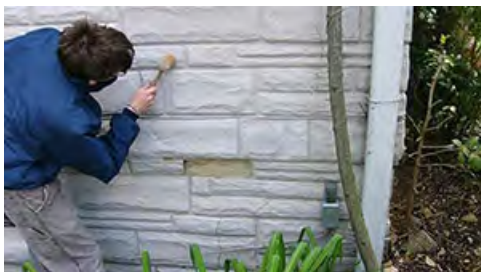
Figure 6. Stucco applied to an exterior wall or foundation was intended to function as a watertight surface. Unless maintained, rainwater will penetrate open joints and cracks that may occur over time. A small section of stucco indicates some damage has occurred and a wooden mallet is being used to tap the surface to determine whether the immediate stucco has lost adhesion. Photo: Bryan Blundell.

Exterior walls are designed to help prevent water infiltration, control air infiltration, and serve as a barrier for unwanted animals, birds and insects. The primary maintenance objective is to keep walls in sound condition and to prevent water penetration, insect infestation, and needless decay (Figure 6). Depending on the materials and construction methods, walls should have an even appearance, free from unwanted cracks, and should be able to shed excess moisture. Where surfaces are significantly misaligned or where there are bulging wall sections or cracks indicative of potential structural problems, seek professional guidance as to the cause of distress and appropriate corrective measures. Wood-frame construction generally will require more frequent maintenance than buildings constructed of brick, stone, or terra cotta (Figure 7).

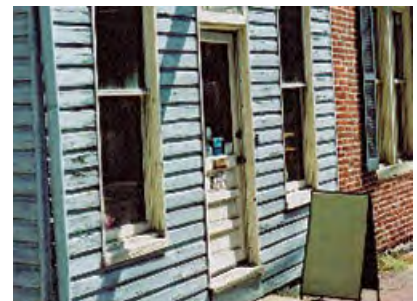
Figure 8. The paint on the siding of this south-facing wall needs to be scraped, sanded, primed and repainted. Postponing such work will lead to further paint failure, require greater preparatory costs, and could even result in the need to replace some siding. Photo: Charles Fisher.

- Excessive damp spots, often accompanied by staining, peeling paint, moss, or mold; and
- General paint problems (Figure 8).

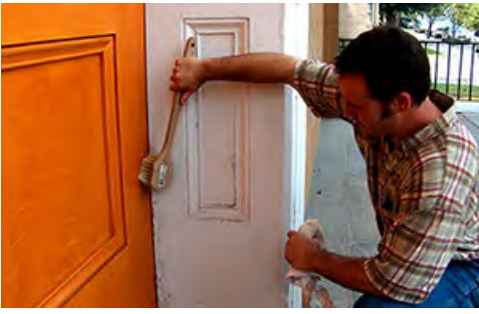
Figure 9. To help extend a repainting cycle, dirt and spider webs should be removed before permanent staining occurs. In this case, a natural bristle brush and a soft damp cloth are being used to remove insect debris and refresh the surface appearance.

- Wash exterior wall surfaces if dirt or other deposits are causing damage or hiding deterioration; extend scheduled times for cleaning for cosmetic purposes to reduce frequency (Figure 9). When cleaning, use the gentlest means possible; start with natural bristle brushes and water and only add a mild phosphate-free detergent if necessary. Use non-abrasive cleaning methods and low-pressure water from a garden hose. For most building materials, such as wood and brick, avoid abrasive methods such as mechanical scrapers and high-pressure water or air and such additives as sand, natural soda, ice crystals, or rubber products. All abrasives remove some portion of the surface and power-washing drives excessive moisture into wall materials and even into wall cavities and interior walls. If using a mild detergent, two people are recommended, one to brush and one to prewet and rinse. When graffiti or stains are present, consult a preservation specialist who may use poultices or mild chemicals to remove the stain. If the entire building needs cleaning other than described above, consult a specialist.

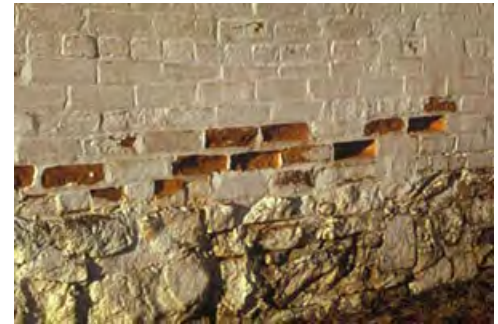
Figure 10. Repointing of masonry should usually be approached as repair rather than maintenance work in part because of the need for a skilled mason familiar with historic mortar. In this case, a moisture condition was not corrected and the use of a waterproof coating and off-the-shelf Portland cement mortar trapped water and resulted in further damage to these 19th century bricks. Photo: NPS files

- Repoint masonry in areas where mortar is loose or where masonry units have settled. Resolve cause of cracks or failure before resetting units and repointing. Rake out joints by hand, generally avoiding rotary saws or drills, to a depth of 2 ½ times the width of the joint (or until sound mortar is encountered), to make sure that fresh mortar will not pop out. Repointing mortar should be lime-rich and formulated to be slightly weaker than the masonry units and to match the historic mortar in color, width, appearance, and tooling. Off-the-shelf pre-mixed cement mortars are not appropriate for most historic buildings. Avoid use of joint sealants in place of mortar on vertical masonry wall surfaces, as they are not breathable and can lead to moisture-related damage of the adjacent masonry (Figure 10).

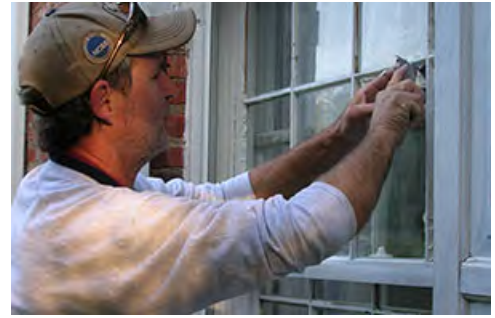
Figure 11. Glazing putty should be maintained in sound condition to prevent unwanted air infiltration and water damage. New glazing putty should be pulled tight to the glass and edge of the wood, creating a clean bevel that matches the historic glazing

- Replace broken or missing glass as soon as possible; in some cases cracked glass may be repaired using specialty glues. For historic crown glass and early cylinder glass, a conservation approach should be considered to repair limited cracks. Where panes with a distinct appearance are missing, specialty glass should be obtained to match, with sufficient inventory kept for future needs. Avoid using mechanical devices to remove old putty and match historic putty bevels or details when undertaking work.
- Reputty window glazing where putty is deteriorated or missing. Take care in removing putty so as not to crack or break old glass or damage muntins and sash frames. Re-glaze with either traditionally formulated oil putties or modern synthetic ones, making sure to properly bed the glass and secure with glazing points (Figure 11).

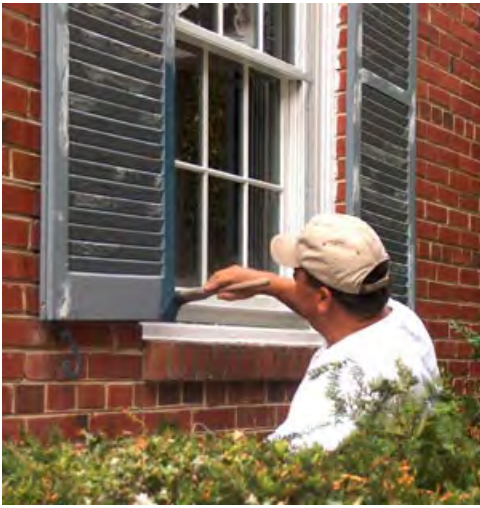
Figure 12. Good surface preparation is essential for long lasting paint. Scraping loose paint, filling nail holes and cracks, sanding, and wiping with a damp cloth prior to repainting are all important steps whether touching up small areas or repainting an entire feature. Always use a manufacturer's best quality paint. Windows and shutters may need repainting every five to seven years, depending on exposure and climate.

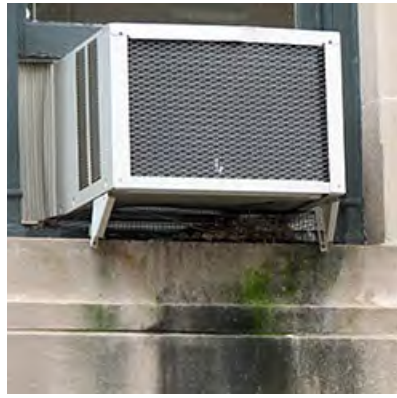
Figure 13. Window air conditioning units can cause damage to surfaces below when condensation drips in an uncontrolled manner. Drip extension tubes can sometimes be added to direct the discharge.

- Remove debris beneath window air conditioning units and ensure that water from units does not drain onto sills or wall surfaces below (Figure 13). Removal of air conditioning units when not in season is recommended.

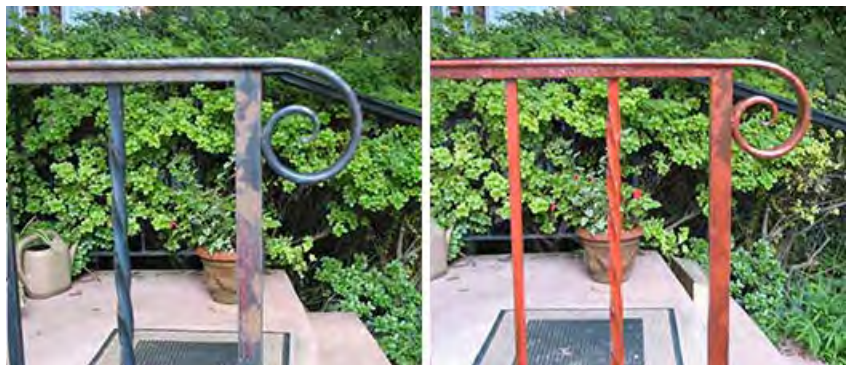
Figure 15. Metal projecting elements on a building, such as sign armatures and railings, are easily subject to rust and decay. Proper surface preparation to remove rust is essential. Special metal primers and topcoats should be use

- Secure any loose connections, such as on porch rails or fire escapes.
- Maintain ferrous metal components by following manufacturer's recommendation for cleaning and repainting. Remove rust and corrosion from porch handrails, balconies, fire escapes, and other metal features; prepare, prime, and repaint using a corrosion-inhibitive coating system. Apply new primer before new corrosion sets in, followed by new topcoat. Take appropriate safety measures when dealing with existing lead-based paint and in using corrosion-removal products (Figure 15).

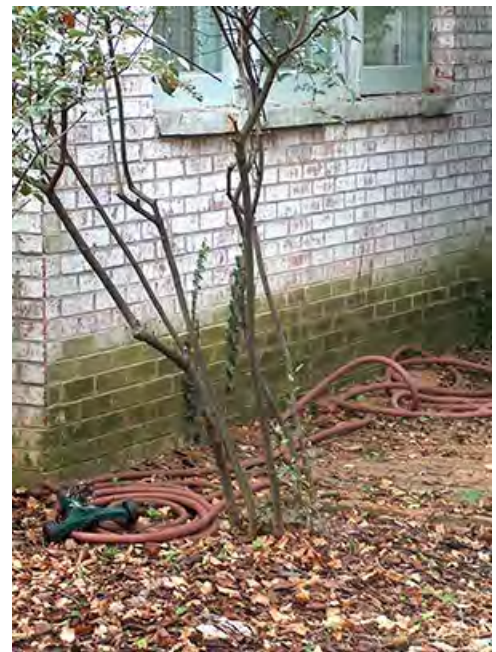
Figure 16. This chronically wet area has a mildew bloom brought on by heat generated from the air-conditioning condenser unit. The dampness could be caused by a clogged roof gutter, improper grading, or a leaking hose bibb.

- depressions or grade sloping toward the foundation; standing water after a storm;
- material deterioration at or near the foundation, including loss of mortar in masonry, rotting wood clapboards, or settlement cracks in the lower sections of wall;
- evidence of animal or pest infestation;
- vegetation growing close to the foundation, including trees, shrubs and planting beds;
- evidence of moisture damage from lawn and garden in-ground sprinkler systems;
- evidence of moss or mold from damp conditions or poorly situated downspout splash blocks (Figure 16); and
- blocked downspout drainage boots or clogged areaway grates.

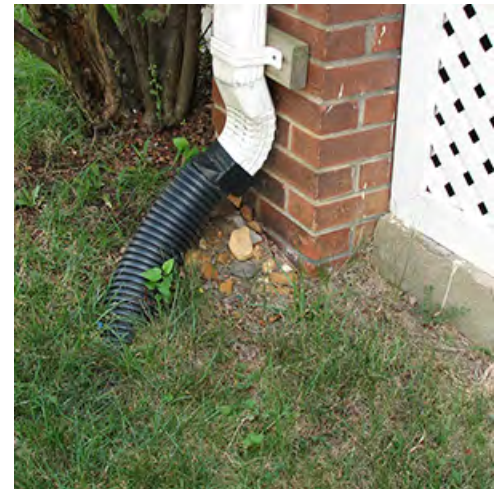
Figure 17. Extending downspouts at their base is one of the basic steps to reduce dampness in basements, crawl spaces and around foundations. Extensions should be buried, if possible, for aesthetics, ease of lawn care, and to avoid creating a tripping hazard. Photo: NPS files.

- Reset splash blocks at the end of downspouts or add extender tubes to the end of downspouts as necessary (Figure 17).
- Lubricate operable foundation vent grilles to facilitate seasonal use; paint as needed.
