Wareham Historical Society Historic Building Survey

October 21, 2013

Great Neck Union Chapel
Old District School No. 6
Old Methodist Meeting House
Fearing Tavern Museum
Captain Kendrick House

DURLAND ■ VAN VOORHIS

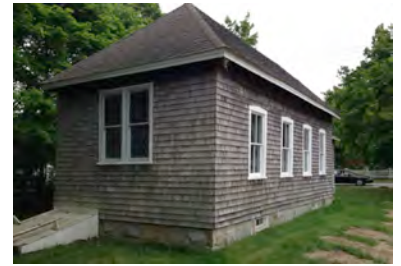
UC-1 Hip roof at east end of Chapel

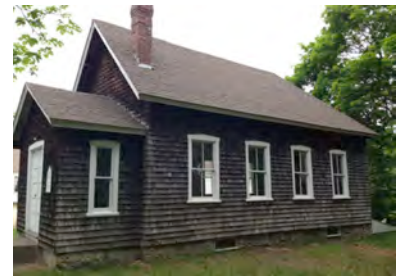
UC-2 South side of Chapel

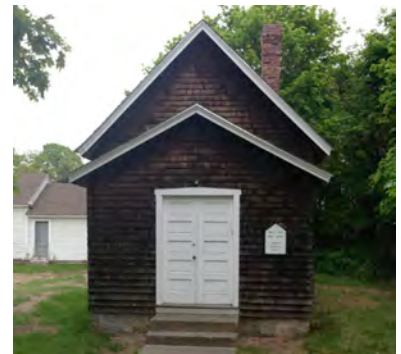
The site abuts the old town green and it is not difficult to imagine the area as the old town center. It is flat with only a slight pitch down from the west to the east. Most of the lot is covered with grass and a few immature trees. The center of the lot is covered with gravel and serves as a makeshift parking lot. The western edge of the lot is bound by a concrete sidewalk with a single curb cut into it. The Chapel is oriented east/west with its gable end and entry vestibule facing Main Street. (UC-3).

UC-3 Chapel entrance

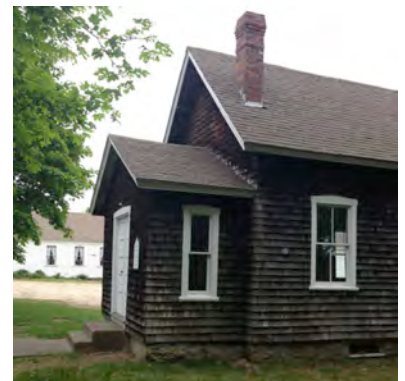
UC-8 Entry vestibule & sanctuary

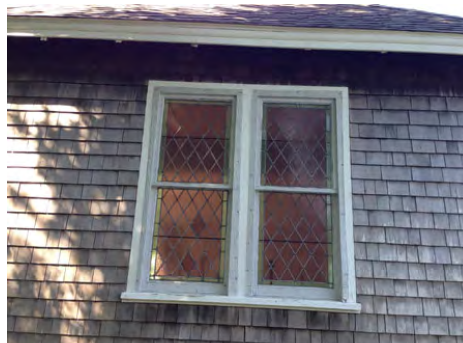
UC-15 Leaded glass windows

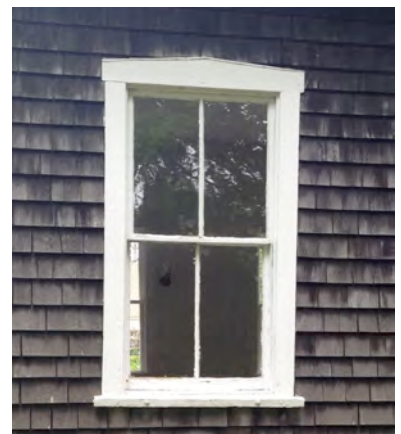
UC-14 Typical wood window

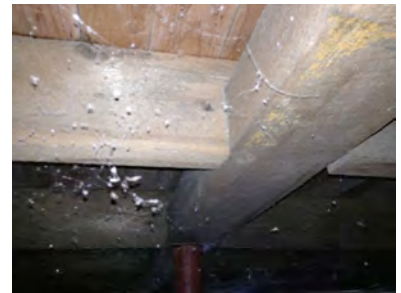
UC-17 Joists notched into beam

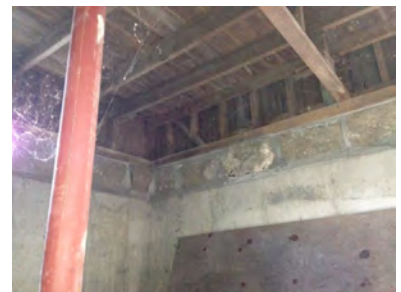
UC-18 Framing under raised floor area

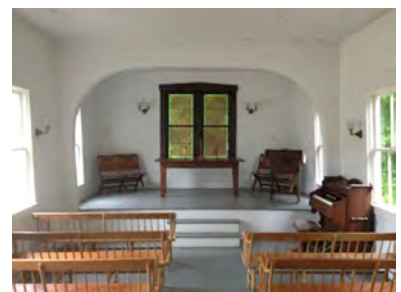
UC-19 Existing seating arrangement

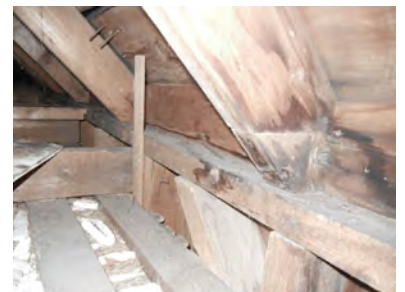
UC-22 Top plate of south wall

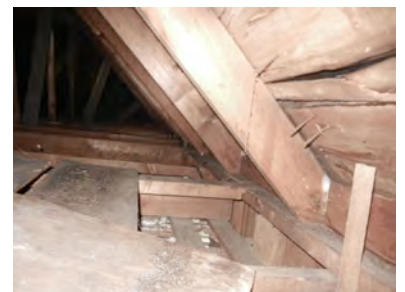
UC-23 Existing roof & ceiling framing

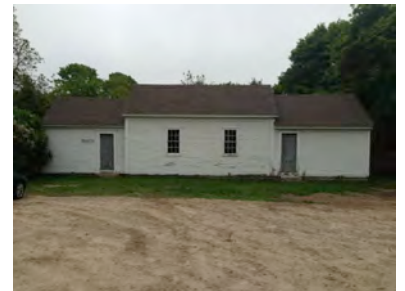
DS-1 View facing east from parking lot

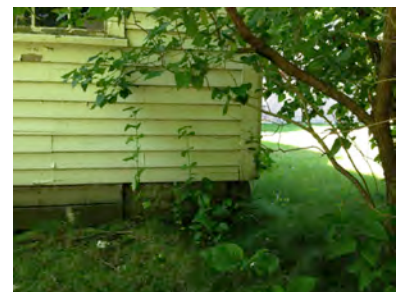
DS-2 Overgrown plantings at north end

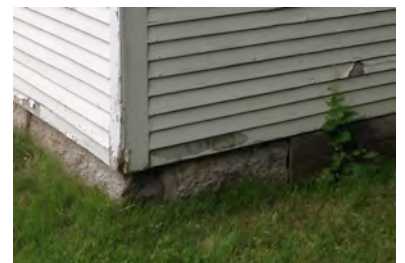
The building is set on new concrete piers except along the west side where a granite block foundation veneer was installed when the building was moved (DS-3). The veneer foundation is clearly a recreation because the joints between the classroom space and the storage wing to the south were not built with the spaces above. There should be a foundation joint where the new space was added (DS-4). The north, south and east sides are covered by a lattice work of pressure-treated dimensional lumber, some panels of which appear to be removable. The crawl space underneath is relatively dry, but gutters and downspouts, a perimeter drainage system or careful grading around the building would keep the space even drier. There also appear to be signs of animals living in the crawl space.

DS-3 Masonry veneer wraps SW corner

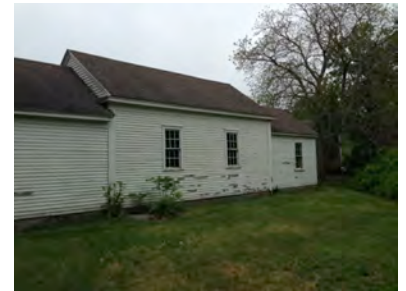
DS-7 Existing asphalt shingle roof

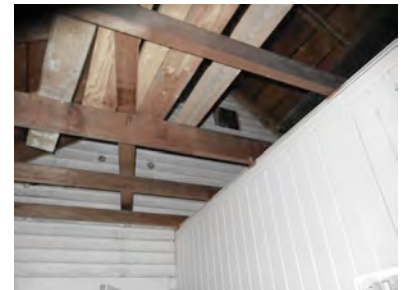
DS-8 Roof framing at storage addition

The gable roof structure of the original school house and the two additions appears to have been conventionally framed with rafters and ties at the eave elevation (DS-8). The roofs, walls and ceilings do not appear to have any obvious signs of structural distress. Therefore, I don't anticipate the need for new structural reinforcements.

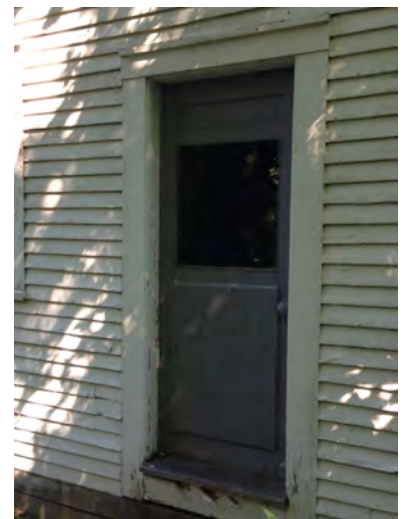
DS-9 South end exterior door

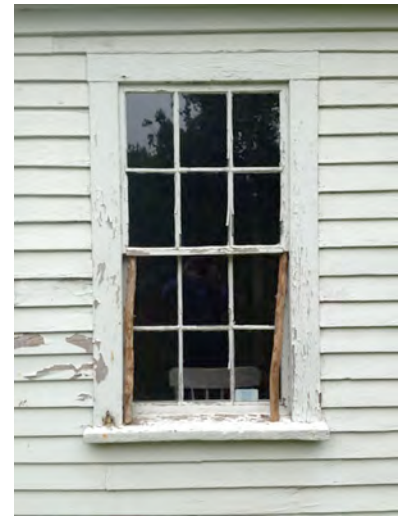
DS-10 Existing 6/6 wood double-hung window

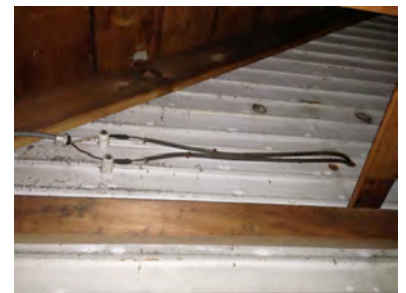
unreliable and sometimes can be quite dangerous. All knob and tube wiring should be removed completely, whether active or not. The wiring is very easily shorted and is frequently the cause of fires in old buildings.

DS-11 Knob & tube wiring

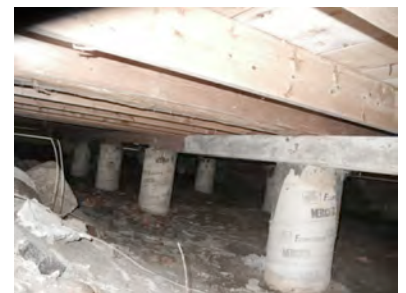
The first floor is framed over a crawl space. The wood joists are supported by perimeter and interior wood beams that are supported by a series of concrete piers (DS-12). Access to the floor framing was not accessible, however, from an access hole to one location of the perimeter skit board (DS-13), the framing appeared to be free of decay or rot and the concrete piers appeared to have been located in some organized fashion. Due to limited access, a general analysis and close inspection of the existing floor framing was not possible.

However, the floors appeared to be relatively sound with no obvious soft areas and relatively level; however, it appears to my limited perspective that some of the floor joists were not bearing on the wood beams. I suggest all of the joists be inspected and shims added to ensure the joists are bearing solid on the intermediate wood beams.

DS-12 New floor framing

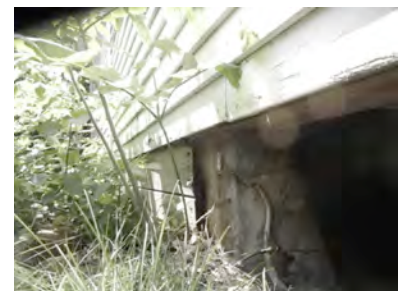
DS-13 Perimeter framing detail

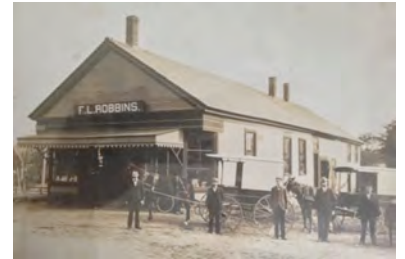
MH-1 Old Methodist Meeting House c. 1890

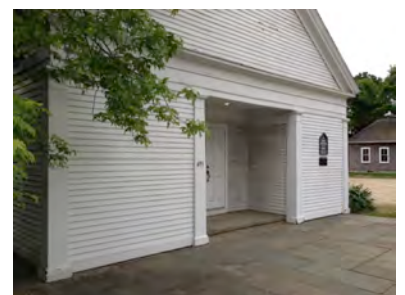
There is a large bluestone patio outside the main entrance on the western face of the main hall that extends virtually all the way to Main Street (MH-4). This is complimented by a blue stone landing just outside of the main entrance doors inside the "portico".

MH-4 Bluestone paving at main entrance

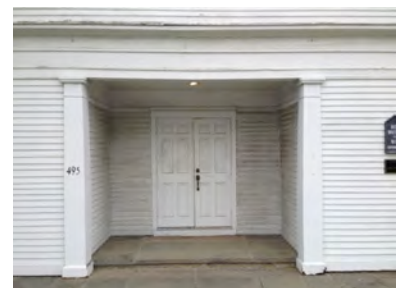
MM-10 Existing front door

There is a pair of six-panel exterior wood doors tucked inside a rectangular recess between the center two pilasters that serves as the main entrance to the meeting house (MH-10). These are in good condition but would benefit from a careful scraping, sanding and repainting. The hardware has a pull with a thumb latch, a single leaf is less than 34 inches wide, and there is a small step up to the landing from the patio, all of which makes the main entry somewhat inaccessible.

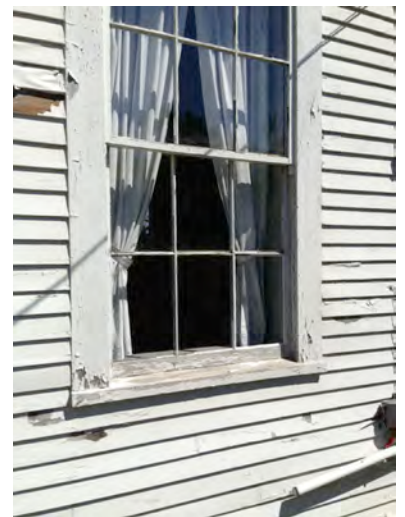
The windows are typically six-over-six wood double-hung units. The sash themselves are generally in fair condition, but the glazing and paint have failed nearly completely (MH-12). All of the windows should have the glazing removed, the sash scraped, sanded, and primed. The glass should be reset and the windows entirely reglazed and repainted. New or salvaged blown glass should be used to replace any broken or missing panes. Be sure to match the color and optics for the best fit. Full height stops screwed into the frame provide a clean method for fixing the upper sash in place.

MH-12 Existing window

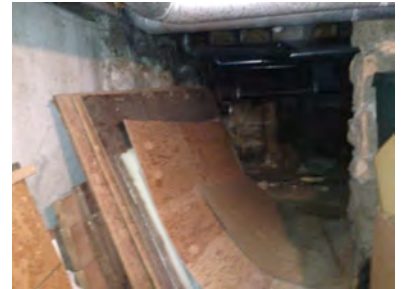
The foundation wall of the original building appears to be a stone wall while the rear addition has a cast in place concrete wall (MH-13). There were no obvious signs of cracking of the foundation or the interior wall finishes that would be indicative of ongoing foundation settlements. Therefore, it appears that the foundation is adequately serving its current use.

MH-13 Existing basement (conc foundation @ left with fieldstone foundation @right & beyond

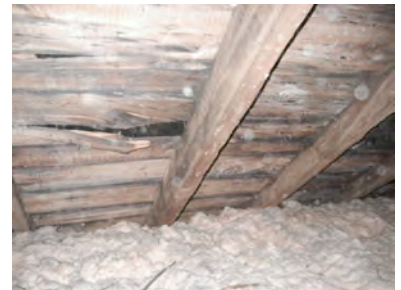
MH-15 Existing roof rafters

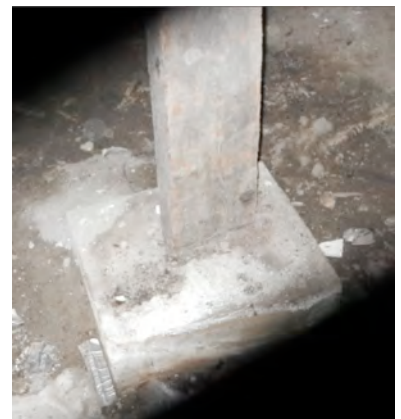
MH-16 Existing concrete footing

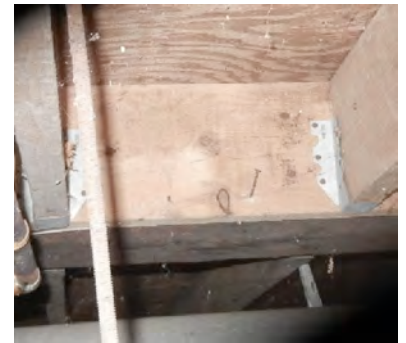
MH-17 Reinforced floor framing

At the very least I suggest all joist hangers be inspected and all hanger nail holes filled and a qualified exterminator periodically inspect and treat any signs of ongoing active insect infestation (MH-17). Also, I suggest any signs of movement (e.g. sagging floors, cracking wall or ceiling finishes, doors and windows that no longer function, etc.) be reported to a professional to investigate the floors for structural issues and ongoing movement.

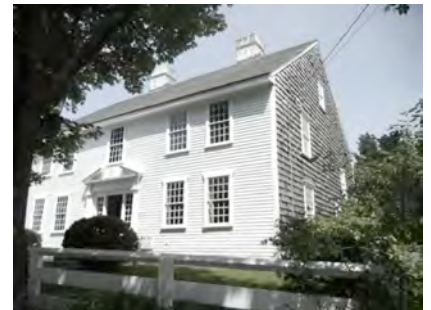
FT-1 Fearing Tavern

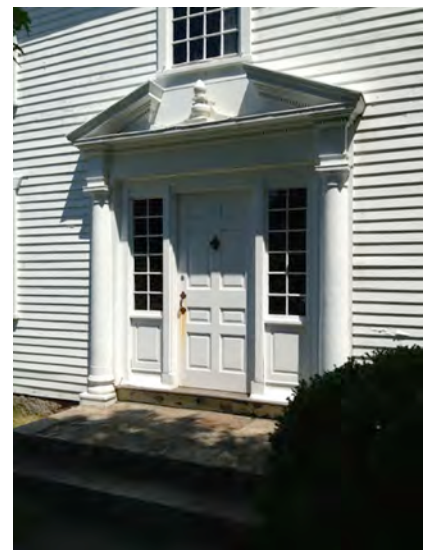
FT-2 Classic Georgian entrance

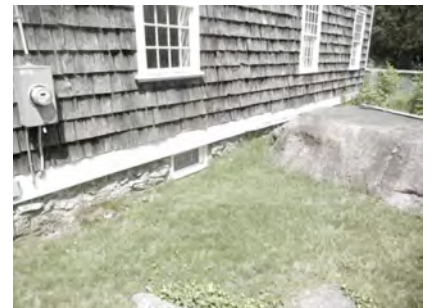
FT-3 East wall bulge behind granite boulder

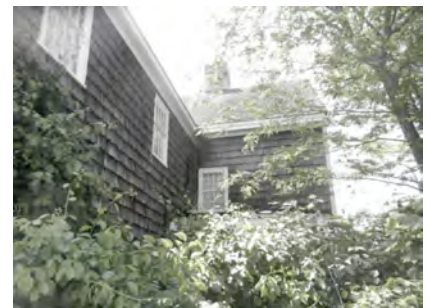
FT-4 Overgrown northwest corner

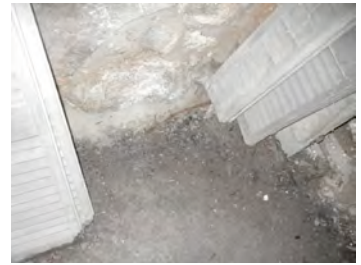
FT-5 Corner of partial cellar

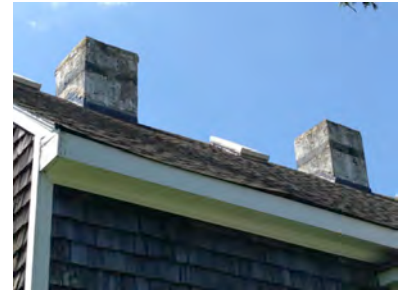
FT-8 Painted brick chimneys

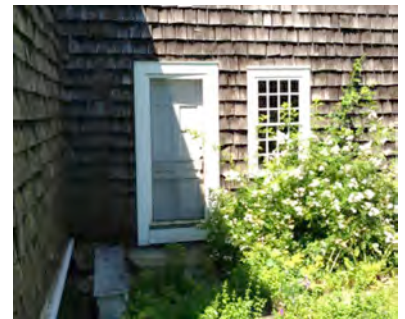
FT-10 Kitchen door

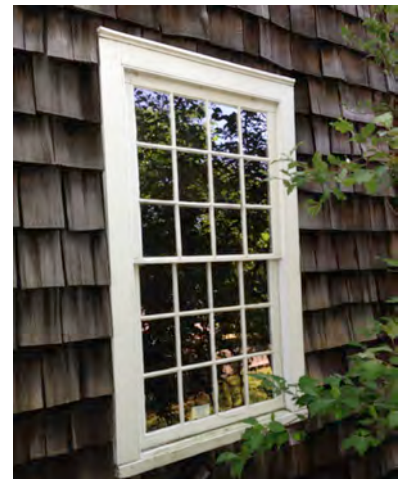
The windows on the main house are 12-over-12 double hung wood windows, a signature detail of Georgian houses. They are in generally good condition, but require at least some glazing repair and repainting. There are several pintles (pieces of earlier hinges), still visible at some of the windows, evidence that shutters were once installed, though no shutters are currently in use. Consideration should be given to reinstalling these wonderfully efficient elements of historic climate control.

FT-11 Typical 12-over-12 window

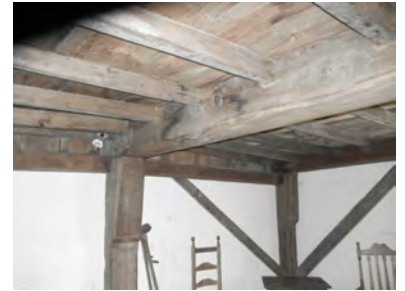
FT-12 Post & beam frame

Typically in a post and beam structure the posts are uninterrupted from the roof to the foundation. However, in my attempt to follow the posts I noted a window at the first floor interrupting the posts and in another place an interior posts could not be tracked.

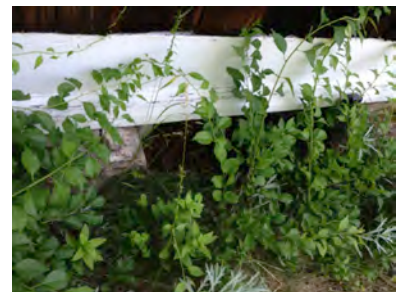
FT-19 Overgrown cellar window

- *All overgrown plantings be cut down to expose the exterior to reduce the possibility of future decay due to moisture and insect infestation (FT-19).*
- *The gutters appear to have been taken off the house. I suggest a drainage bed and possibly a perforated pipe be installed around the perimeter to collect and dispose of surface and roof rainwater off site.*
- *A basement drainage system with a sump and ventilation system be considered in the basement to reduce the moisture levels and reduce the possibility of future rot and decay due to water and insect infestation.*
- *An exterminator inspect and treat the property periodically to inhibit insect and rodent infestation.*
- *I suggest the sag in the 2nd floor be investigated further by a qualified Contractor who can selectively remove and replace interior historic finishes and determine the cause of the sag and possible repairs.*

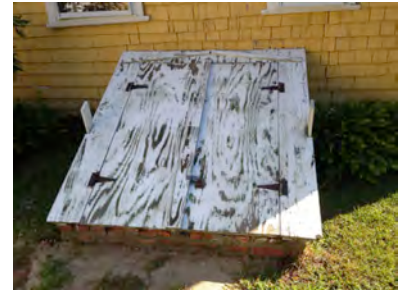
The foundation of the rear ell is fieldstone and requires some repointing and gap filling (KH-5). This should be checked regularly to prevent rodents from getting inside the house. There is a plywood bulkhead door on the southwest side of the main house. While the location may be quite old the material choice, plywood, does not integrate well with the rest of the

KH-6 Existing bulkhead door

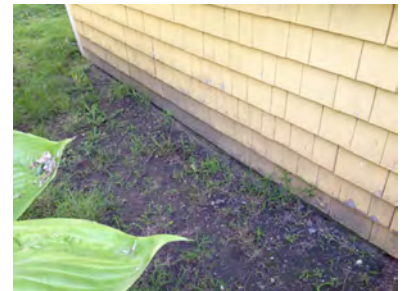
The grade along much of the ell is only a few inches below the siding and even more of the foundation is overgrown with vegetation (KH-7). This condition is not good for the framing and certainly contributes to water infiltration into the cellar and basement.

KH-7 Low clearance between grade & siding

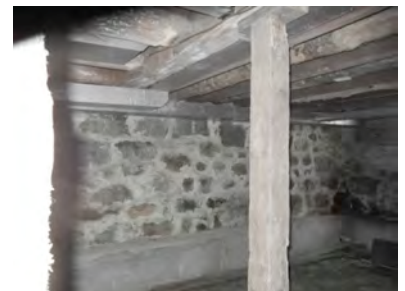
The basement is quite damp and there were pools of standing water visible (KH-8). The dirt floor is covered with small pieces of polyethylene covered with Homosote panels that are completely saturated with water. This should all be removed and replaced with large sheets of heavy, 10 mil poly covered by a few inches of pea stone or $\frac{3}{8}$ " river rock.

KH-8 Existing basement

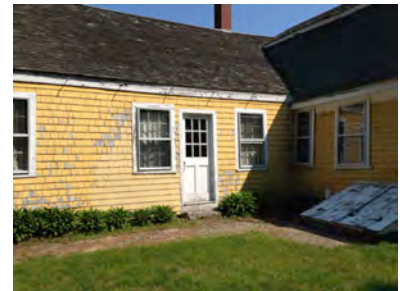
KH-11 Siding patch on ell

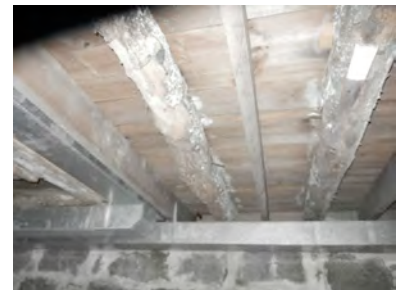
KH-18 Existing framing with reinforcements
